Decentralized energy production: Green future or cybersecurity nightmare?

*The cybersecurity dark side of solar energy
when clouds are involved*

Hoymiles Micro Inverter (MI)
HM-300 (FW 01.00.15)
w/ DTU-Lite (FW 0.3.12)

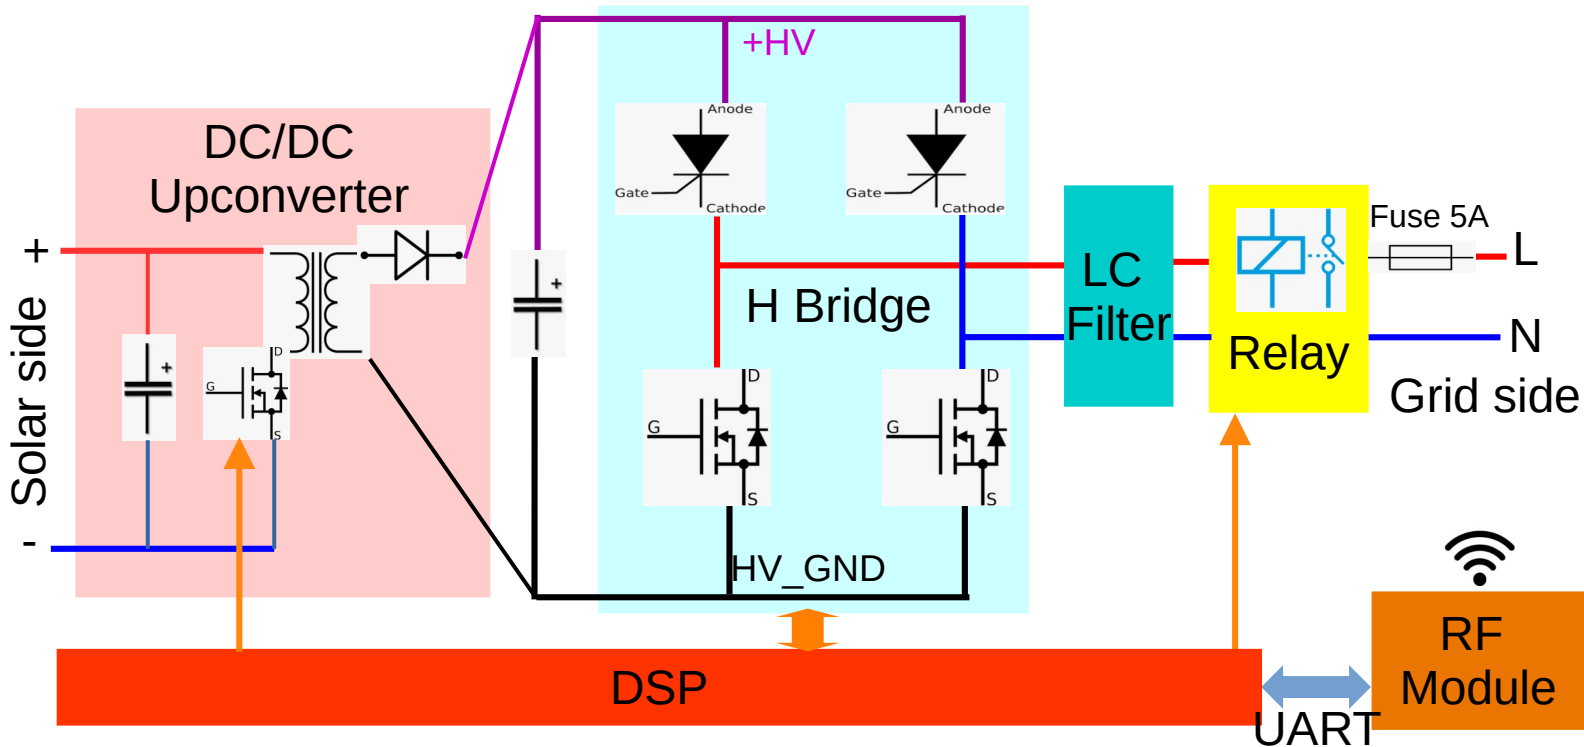
PoC MI side – MI Architecture

Note: simplified view

Relay and some transistors are controlled by Firmware
